THIRD NATIONAL COMMUNICATION ON CLIMATE CHANGE

PROTECTION OF CULTURAL HERITAGE AND CLIMATE CHANGE

VULNERABILITY ASSESSMENT AND ADAPTATION MEASURES

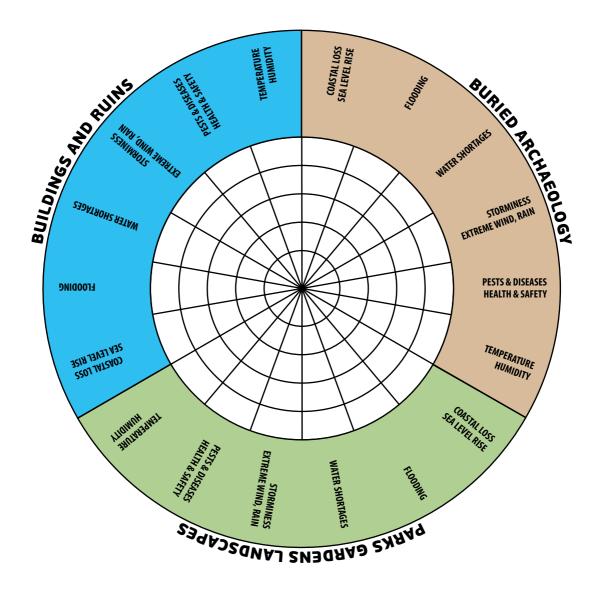
Figure: Key Climate Impacts on Cultural Heritage (Source: UCL, Centre for Sustainable Heritage)

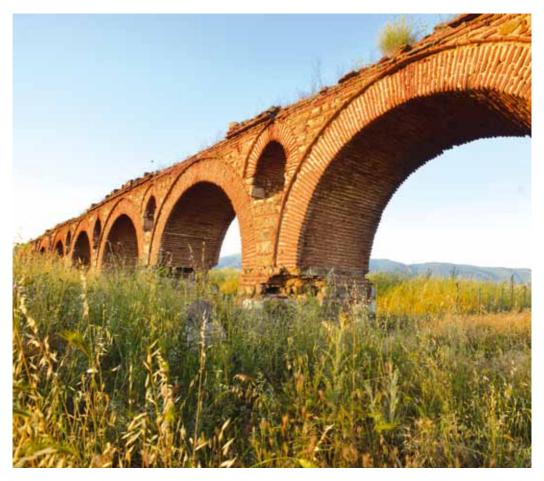
THE SKOPJE AQUADUCT

The Aquaduct near Skopje, in the village of Vizbegovo, is one of the largest preserved Aquaducts in the territories of former Yugoslavia, with 55 remaining arches.

The Skopje Aquaduct is currently in a critical state of conservation. There is conspicuous visible damage to the surface of the structure and some arches have recently collapsed.

The Report identifies the main cause of this damage in the earlier canalization of the River Serava, which altered the ground water saturation of the soil in the southern part of the site. These changes in the level of ground water resulted in uneven soil compression under the pier foundations, causing a number of arches to lean. Further soil movements could cause these structures to collapse.

In addition to damage from ground water saturation, rain-induced damage includes surface water retention. Existing cracks and structural damage allow rain to penetrate more deeply, accelerating erosion and threatening disintegration.

A third cause of damage was found in the uncontrolled growth of vegetation on the upper level of the Aquaduct, with tree roots resulting in cracks.

An increase in the number of days with freeze/thaw cycles, as well as increased heavy rain and flooding, with fluctuations in the water table, together threaten to damage the structure in its entirety. This is because freeze/thaw cycles result in frost shattering, which causes damage to the bricks at the top of the Aquaduct, ultimately leading to the collapse of arches.

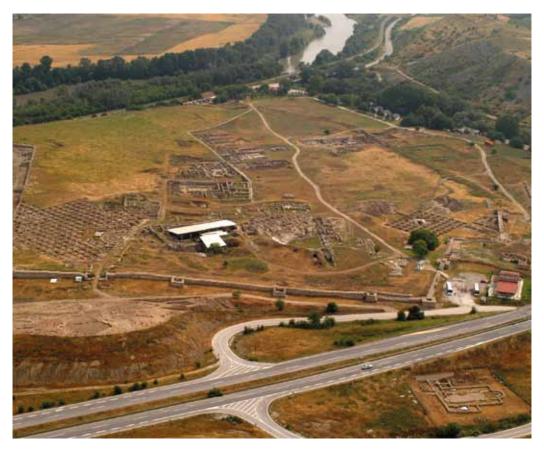
STOBI

Stobi is one of the country's most famous archaeological sites. Located on the main ancient trade route from the River Danube to the Aegean Sea, the first town was founded here in early Roman times where the River Crna joins the River Vardar and the settlement became an important trading centre. The structures that survive today are largely from the Late Hellenistic period, though the site covers all stage in urban development from the early Roman period to the late 6th century.

The field survey undertaken for the Report found that the walls exposed by excavation showed conspicuous damage from the weathering of rocks and the ongoing washout of bonding materials. Frost damage has led to plate-like cracking of the soft sandstone.
